Sandbar Response in Marble and Grand Canyons, Arizona, Following the 2008 High-Flow Experiment on the Colorado River

Scientific Investigation Report 2010–5015

By Joseph E. Hazel, Jr., Paul E. Grams, John C. Schmidt, and Matt Kaplinski

Scientific Investigations Report 2010–5051

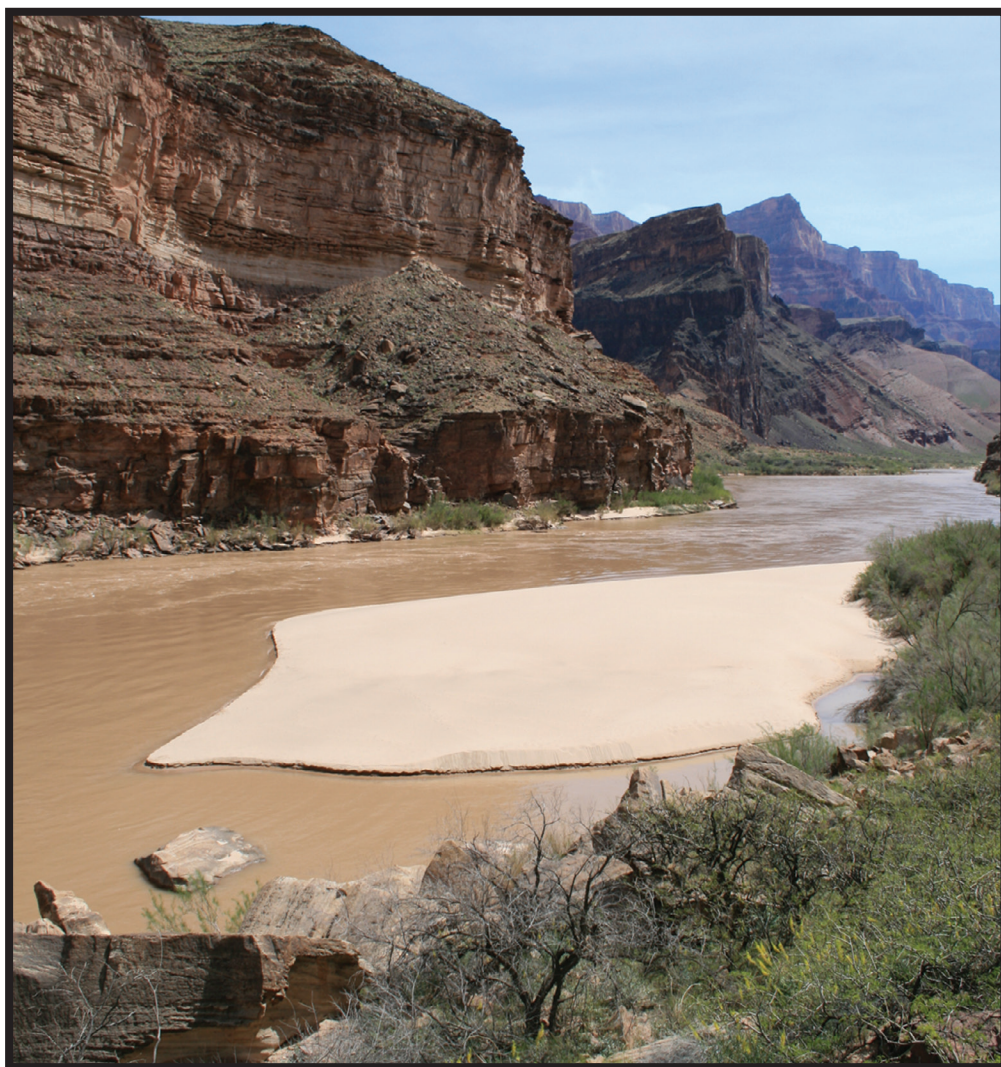
View looking south (downstream) of the Colorado River and the sandbar at Carbon Canyon (study site 65R in Eastern Grand Canyon) on April 4, 2008. Discharge at the time was about 368 m³/s. (Photograph by J.E. Hazel, Jr.)

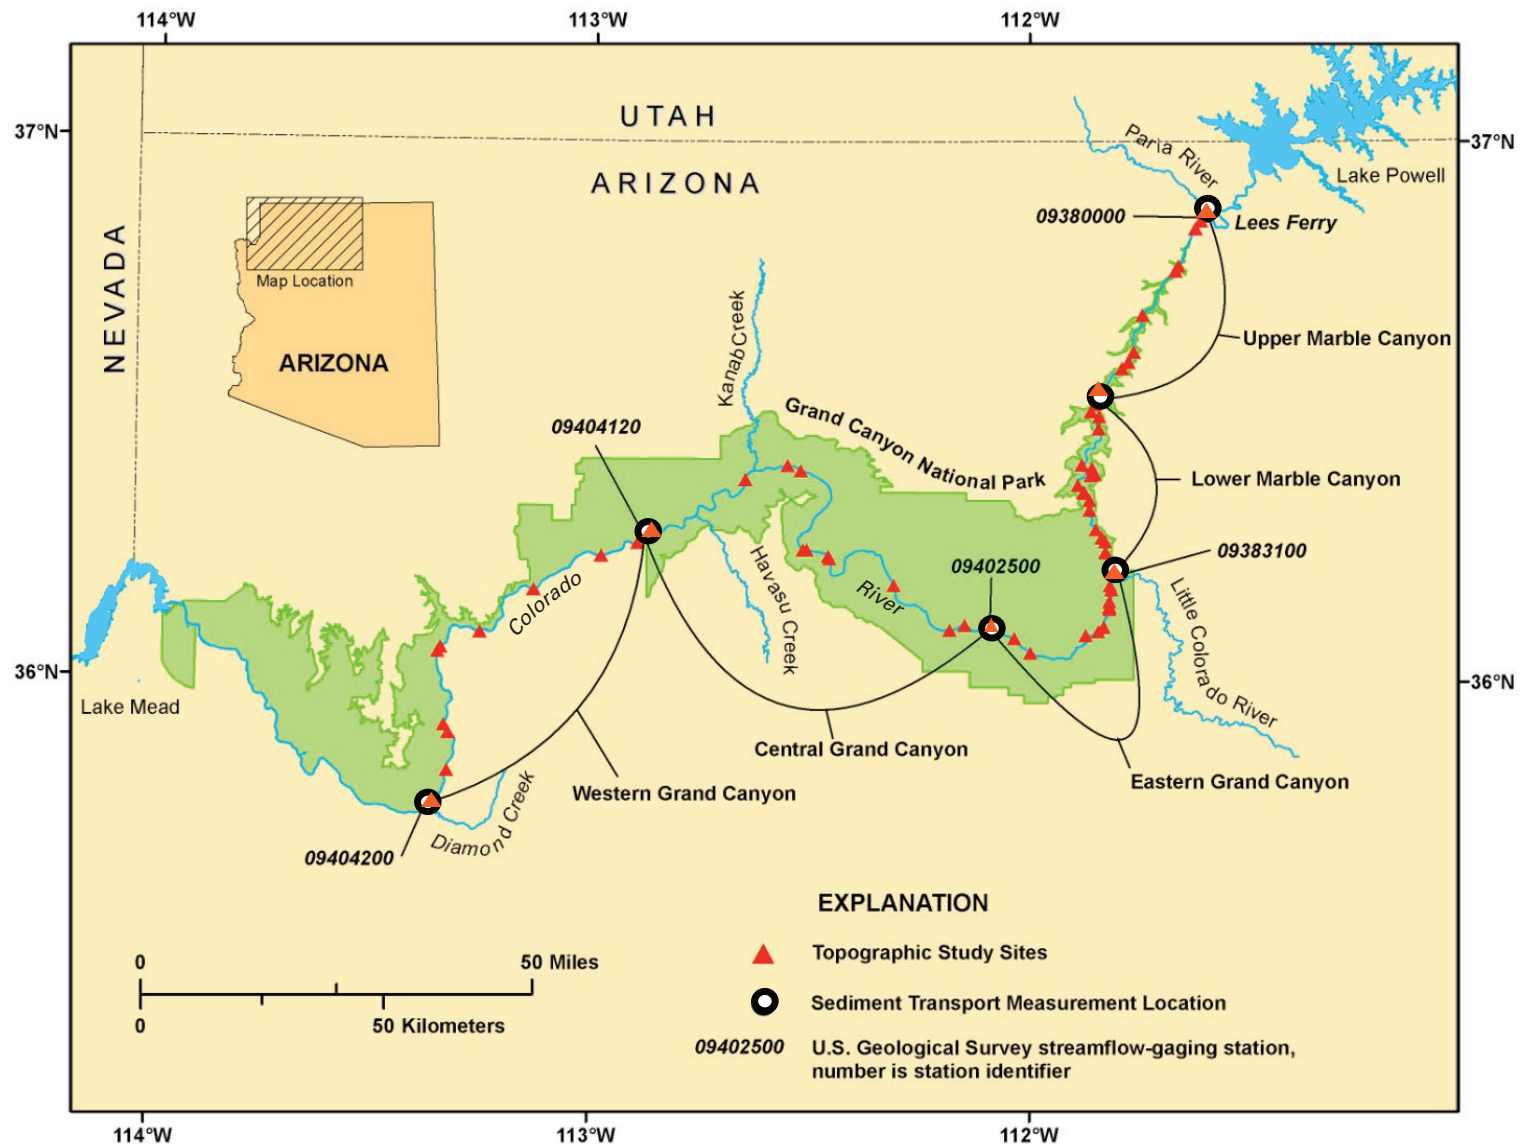
Figure 1. The Colorado River and Grand Canyon National Park, between Lake Powell and Lake Mead reservoirs. Shown are the locations of Lees Ferry, the topographic survey sites, U.S. Geological Survey gaging stations (with station numbers), and the sediment-transport flux monitoring reaches between the sediment-transport measurement sites.

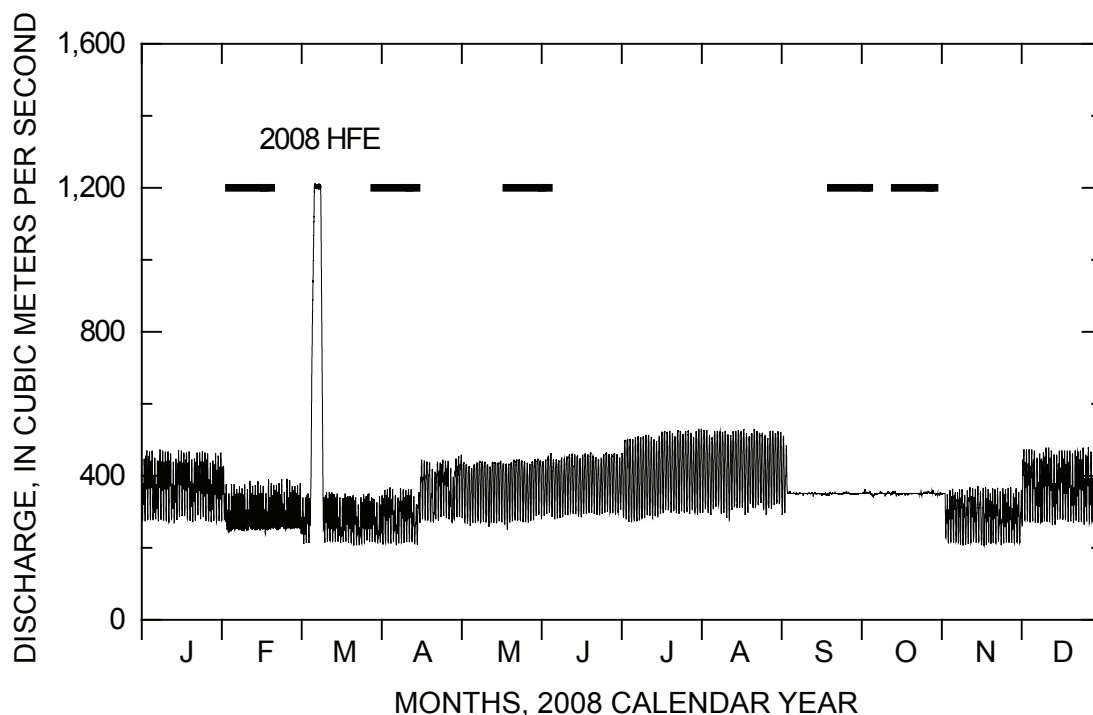
Figure 3. Instantaneous discharge of the Colorado River at USGS streamflow-gaging station (09380000), Lees Ferry, Arizona, for the 2008 calendar year. The solid, horizontal lines indicate the times of survey river trips.

Repeated high-resolution topographic surveys were made on five river trips in 2008 (fig. 3). Each measurement site is located in the downstream part of a fan-eddy complex (fig. 2A). Sixty-two emergent sandbars, consisting of reattachment and/or separation bars, were surveyed down to the 227-m³/s stage at 57 sites (appendix A). Three study sites were not surveyed on the February 2008 river trip (50R, 56R, and 62R), and we utilized data collected in October 2007 as the pre-2008 HFE site condition at these sites. Subaerial topography

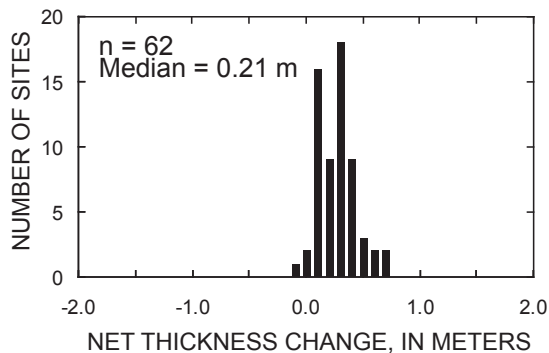
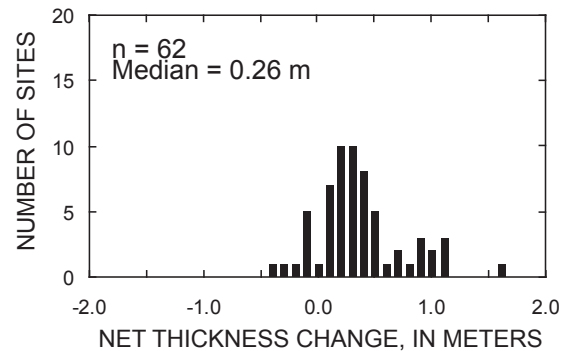
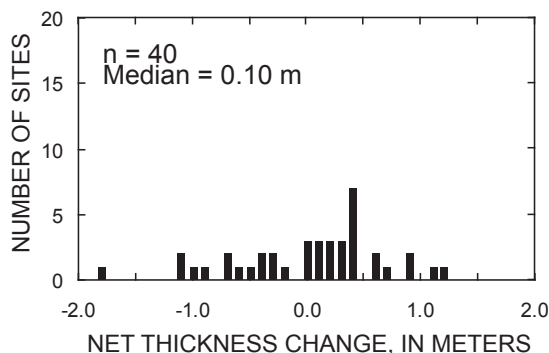
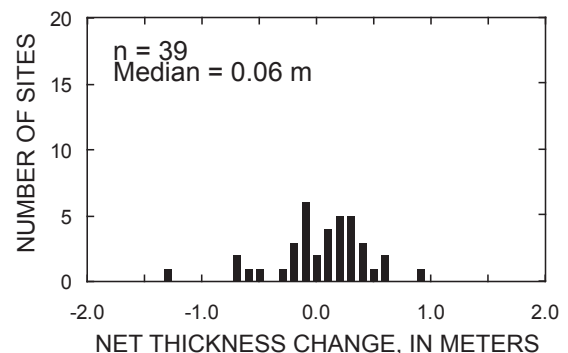
Figure 4. Histograms of net sandbar thickness change between February and April 2008. *A*, High-elevation zone. *B*, Above reference stage. *C*, Total eddy. *D*, Total site (combined eddy and channel).

Deposition in the high-elevation zone occurred at nearly every study site. The volume of sand in this zone increased by more than 5 percent at 48 of the 57 sites surveyed (appendix B, table B1). The median change in high-elevation deposit thickness was 0.21 m, and virtually all sites aggraded to some extent (fig. 4A). Nearly every measured eddy bar aggraded above the reference stage; however, the changes were more variable in the midelevation zone than observed in the high-elevation zone (appendix B, table B2). As a result, the median change in sand thickness above the reference stage was 0.26 m, but the changes from site to site were more variable (fig. 4B).

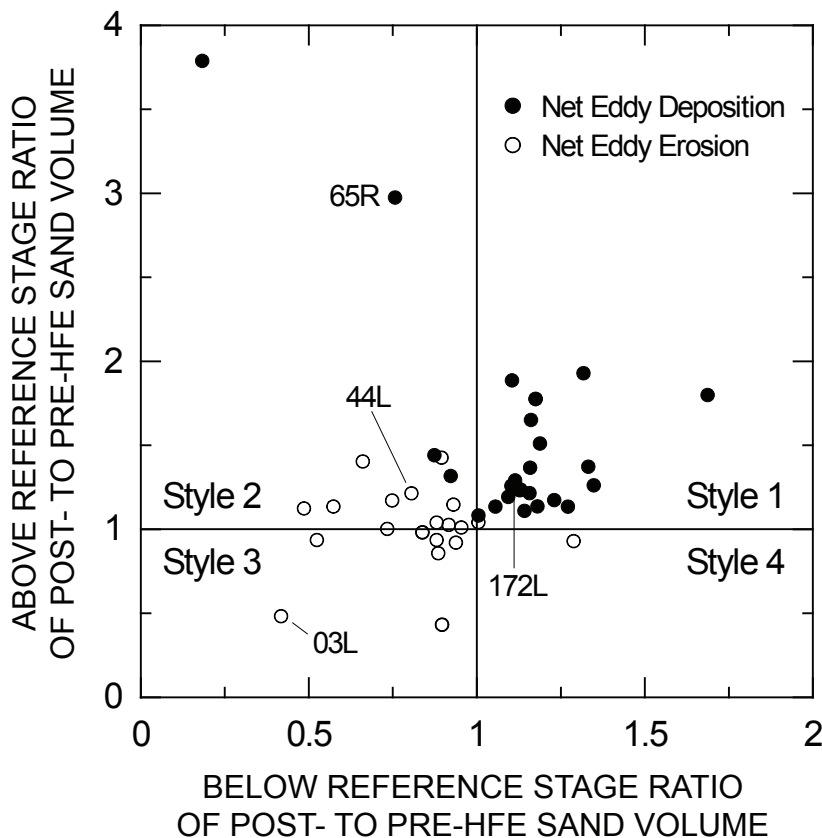
Figure 5. Relation of proportional sand-volume change above reference stage (combined high-elevation and midelevation eddy zones) to below reference stage (combined low-elevation eddy and channel zones) for each site between February and April 2008. The four response styles (Styles 1, 2, 3, and 4) and specific example sites described in the text are shown. Also indicated is net total-eddy deposition or fill as indicated by the net thickness changes shown in figure 4C.

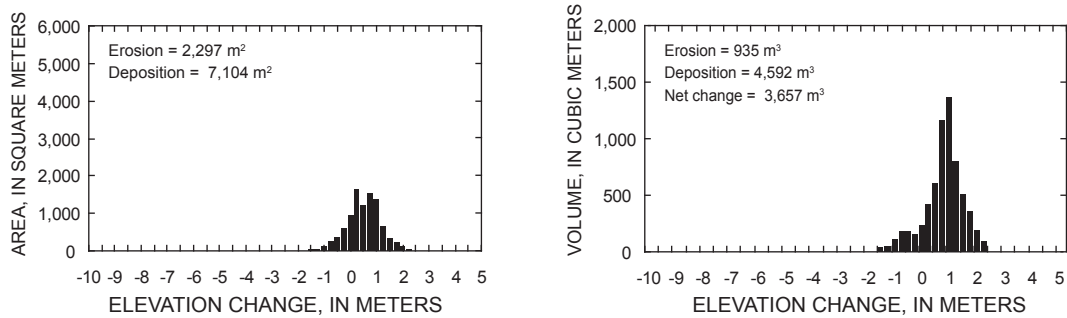
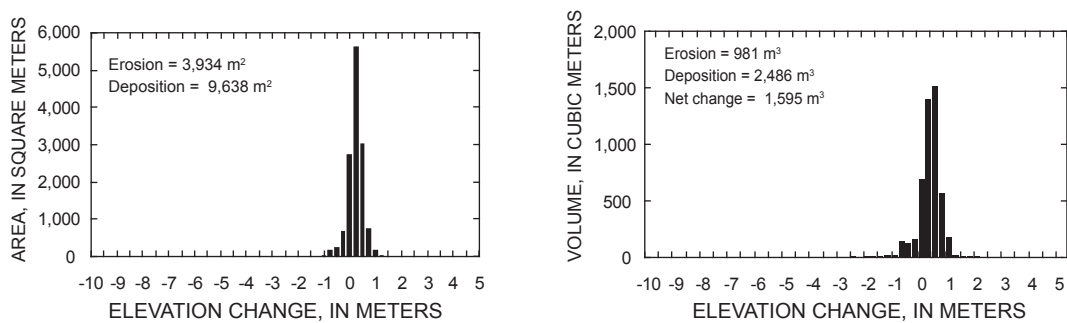
Figure 8. Areal and volumetric elevation-change distributions from the erosion-deposition map at site 172L shown in figure 6C. *A*, Total eddy. *B*, Main channel.

8. These changes are represented as histograms that show the area of the bed and volume of sand associated with each increment of bed elevation change. A unimodal distribution of change, in which 5,800 m² of the total eddy was increased 0.25 to 1.0 m in elevation (62 percent of the eddy computational area), was also observed, as shown in figure 8A. A large part of the channel, about 5,600 m², increased by 0.25 to 0.5 m in elevation (64 percent of the channel computational area). Because the change in sand volume is the product of elevation change and the area over which that change occurred, the greatest volume of deposition occurred where the elevation increased between 0.75 and 1.0 m, and the greatest deposition in the channel occurred where the elevation increased 0.25 to 0.5 m. There was a total of 3,657 m³ of net deposition in the eddy and 1,595 m³ of net deposition in the channel. The site as a whole gained 5,252 m³ of sand (all reported values are listed in the tables contained in appendix B).

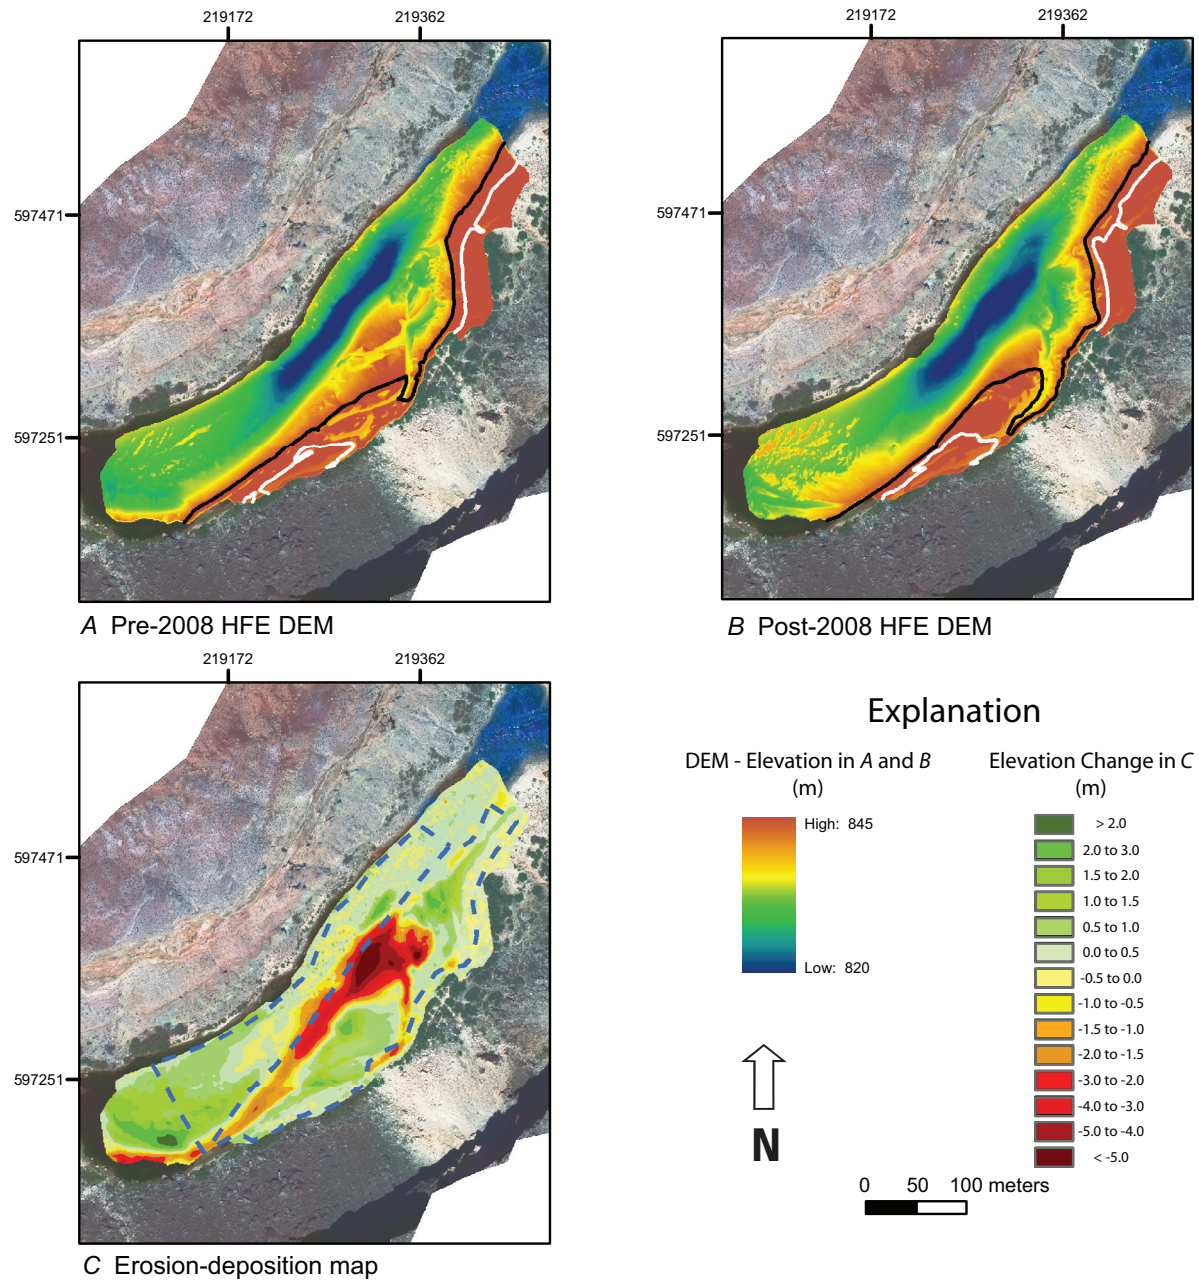
Figure 9. Comparison of repeat topographic and bathymetric surveys collected at site 44L illustrating a Style 2 sandbar response. *A*, Pre-HFE digital elevation model (DEM). *B*, Post-HFE DEM. *C*, The DEMs were differenced against each other to produce a map of spatially distributed elevation change. The solid black and white lines in *A* and *B* are the stage elevations reached by a flow of $227 \text{ m}^3/\text{s}$ and $708 \text{ m}^3/\text{s}$, respectively. The dashed blue line in *C* is the computational boundary described in figure 2. Flow in the main channel is from upper right to lower left. The maps are inset on 2002 aerial photography. Northing and easting on the map projection is 1983 Arizona State Plane, central zone.

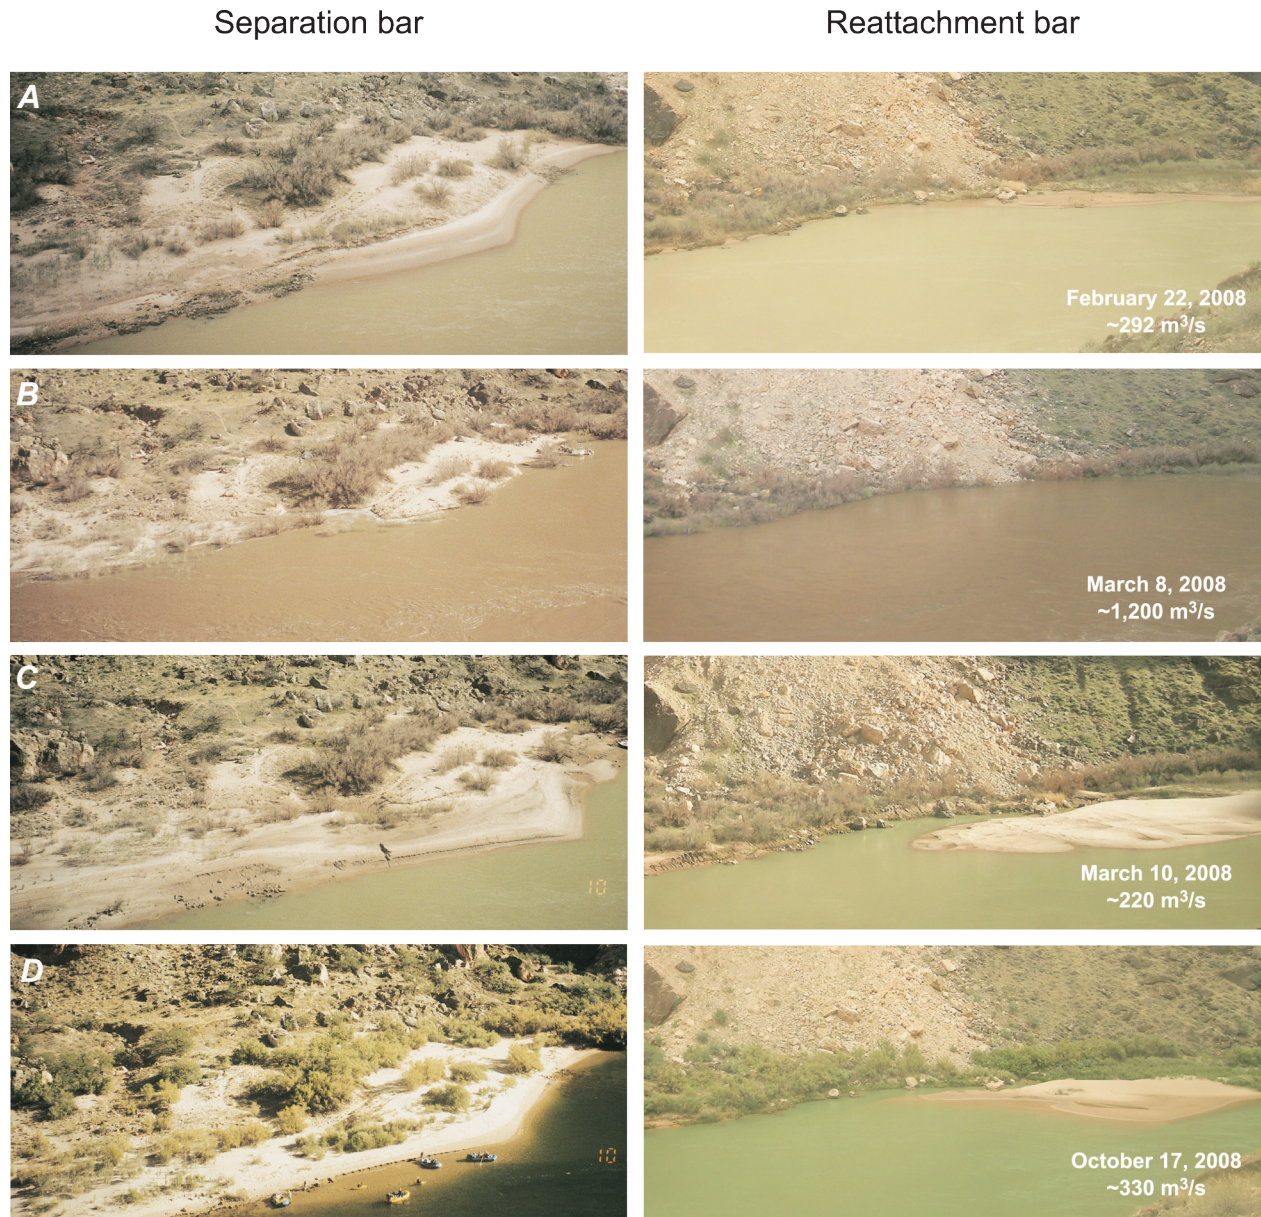
Figure 10. Selected daily photographs of the sandbars at site 44L. In each sequence the separation bar is shown on the left and the reattachment bar is to the right. Flow in main channel is from left to right. The indicated discharges are estimates based on travel time between USGS stream-flow gaging stations on the Colorado River. *A*, Pre-2008 HFE. Note the rocky shoreline on the upstream end of the separation bar and thick vegetation at high-elevation on the reattachment bar. *B*, The extent and height of site inundation by the 2008 HFE is shown. *C*, Post-2008 HFE response. *D*, Erosion in the following months.

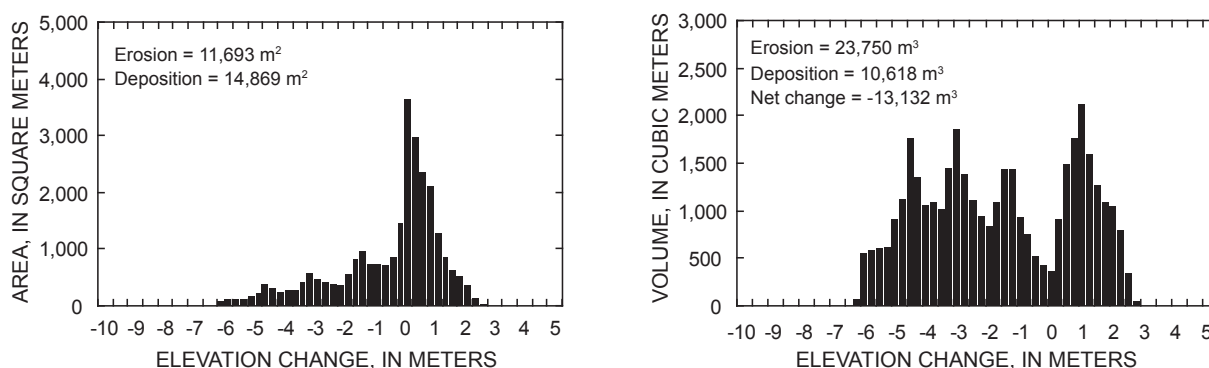
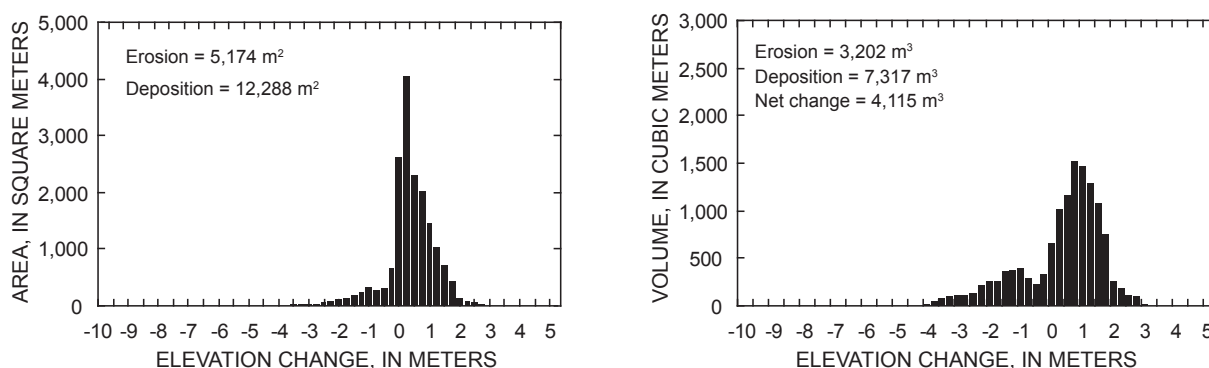
Figure 11. Areal and volumetric elevation-change distributions from the erosion-deposition map at site 44L shown in figure 9C. A, Total eddy. B, Main channel.

The distribution of elevation change in figure 11A shows a bimodal distribution, with widespread, relatively low-magnitude deposition (0.25–1.0 m) over an area of ~11,000 m² (42 percent of the total eddy area). The erosion of the upstream reattachment bar resulted in a smaller area (~7,500 m²) with a depth of scour ranging from 1 to 5 m. In contrast, growth of the dune field on a large region of the channel bed (~11,500 m²) increased the sand elevation by 0.25 to 1.5 m

(66 percent of the channel area; fig. 11B). Because erosion of more than 6 m from the eddy was greater than the volume of sand deposited in the channel, the balance was toward net erosion at the site. There was a total of 13,132 m³ of net sand erosion in the eddy and 4,115 m³ of net deposition in the channel, resulting in total site erosion of 9,017 m³.

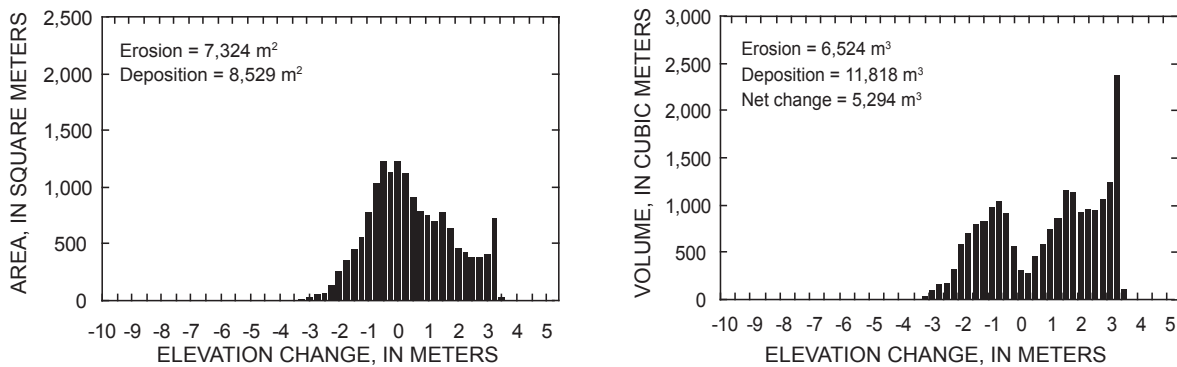
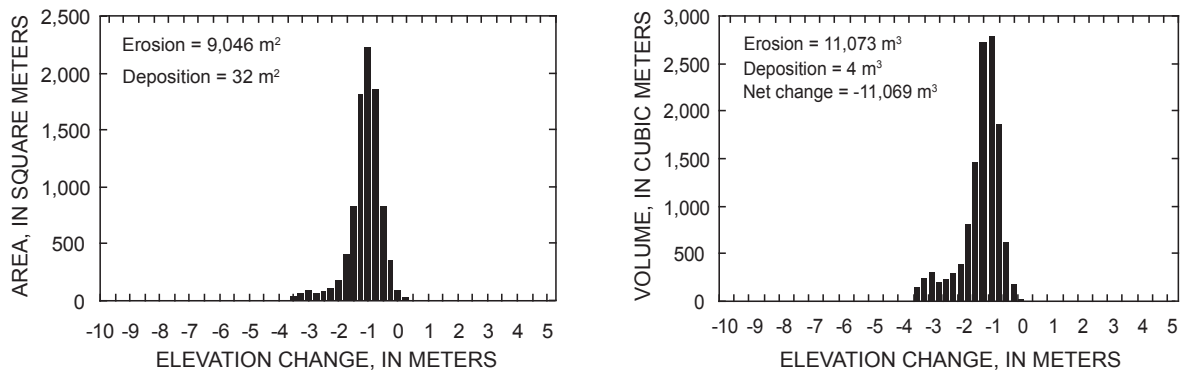
Figure 14. Areal and volumetric elevation-change distributions from the erosion-deposition map at site 65R shown in figure 12C. A, Total eddy. B, Main channel.

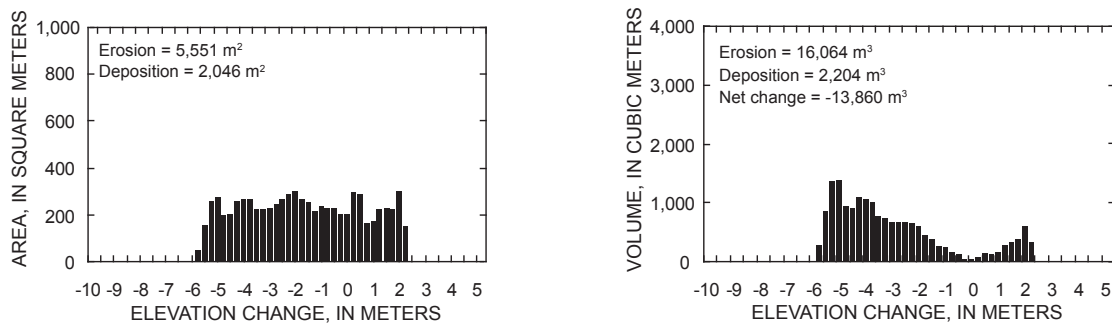
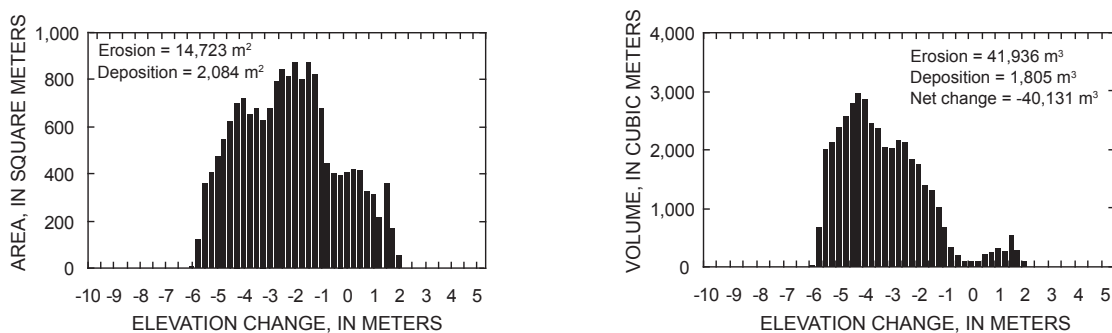
Figure 17. Areal and volumetric elevation-change distributions from the erosion-deposition map at site 3L shown in figure 15C. *A*, The total eddy. *B*, Main channel.

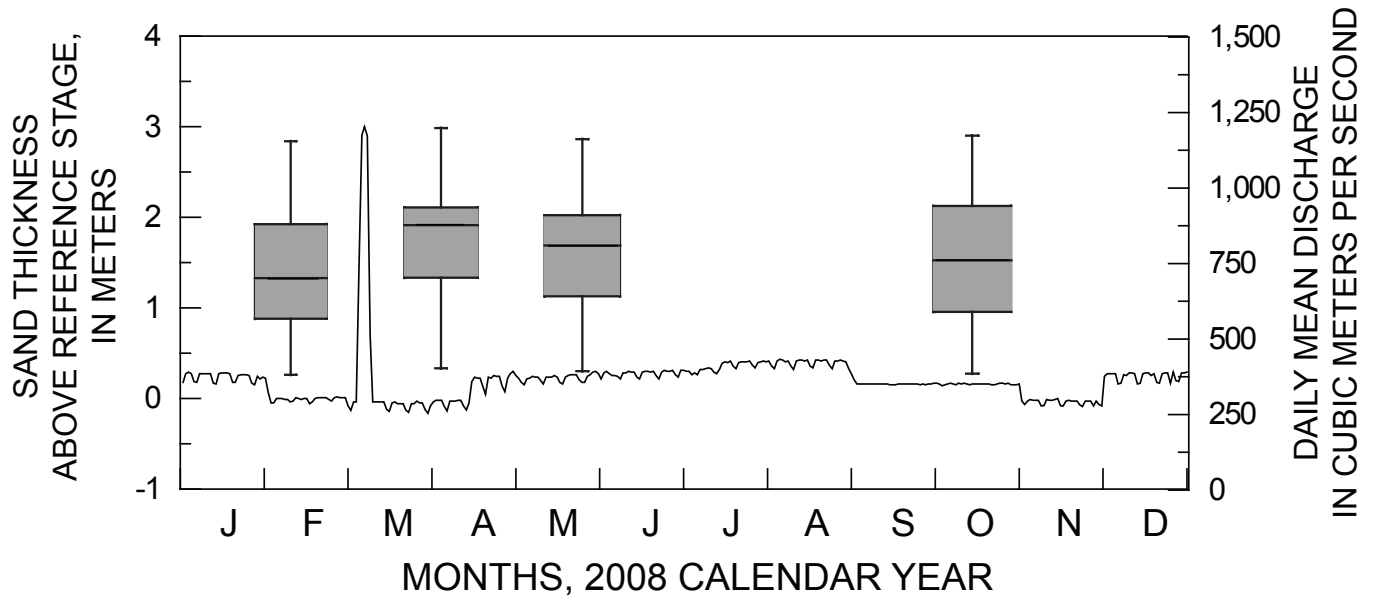
Figure 20. Boxplot showing temporal sequence of deposit thickness above the reference stage compared to daily mean discharge following the 2008 HFE. A boxplot summarizes the distribution of data by showing the interquartile range (25th percentile to 75th percentile) as the height of the box, the median value as the center line within the box, lines drawn to smallest and largest values within one step (equal to 1.5 times the interquartile range) beyond either end of the box, and outliers (values greater than two steps outside the box) as circles.

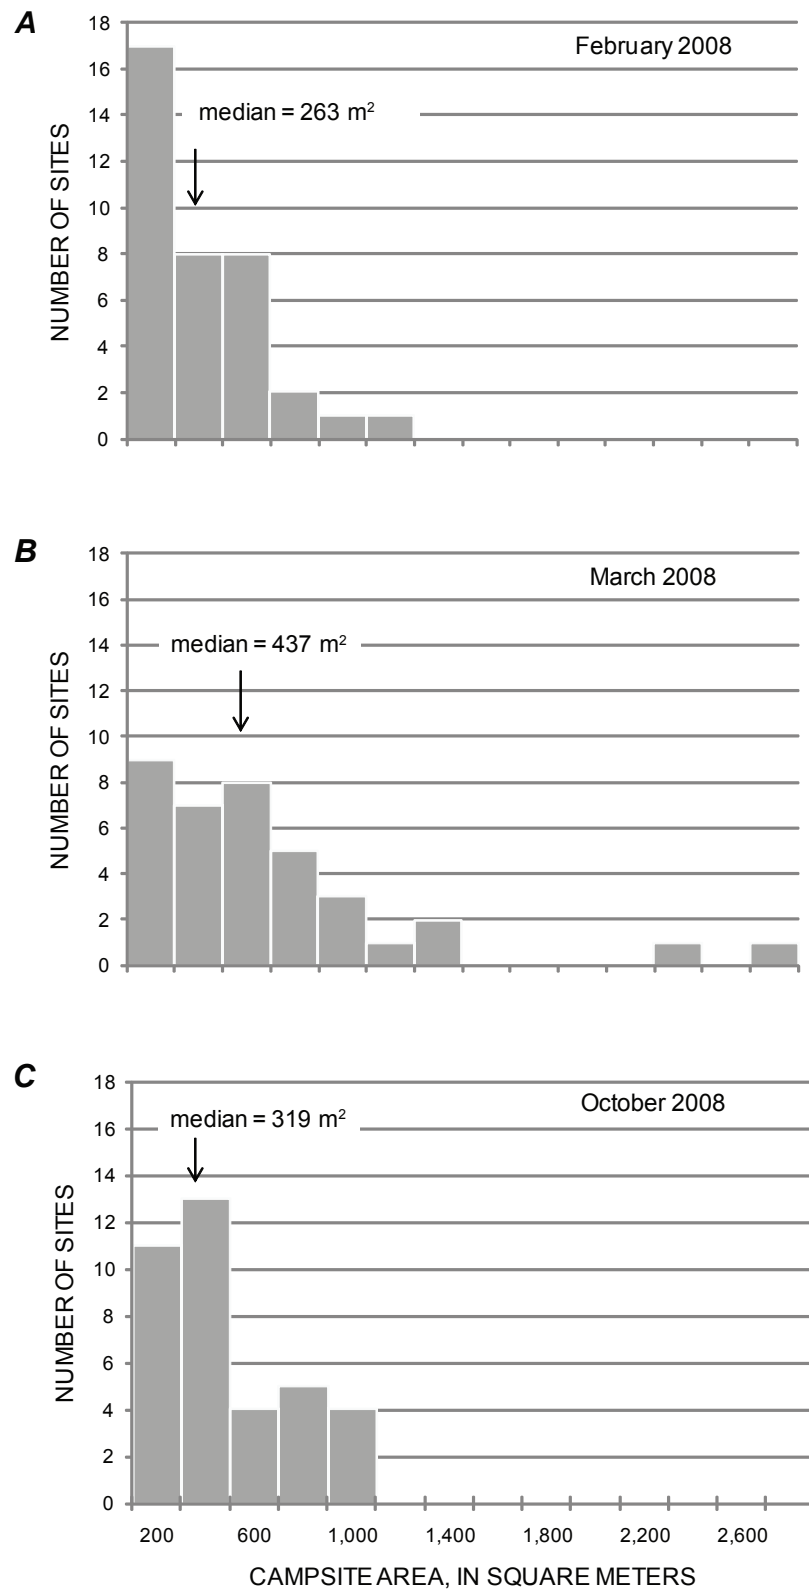
Figure 21. Histograms showing the distribution of campsite area above the reference stage (combined mid- and high-elevation zones shown on figure 2C). *A*, February 2008. *B*, April 2008. *C*, Six months after the 2008 HFE.

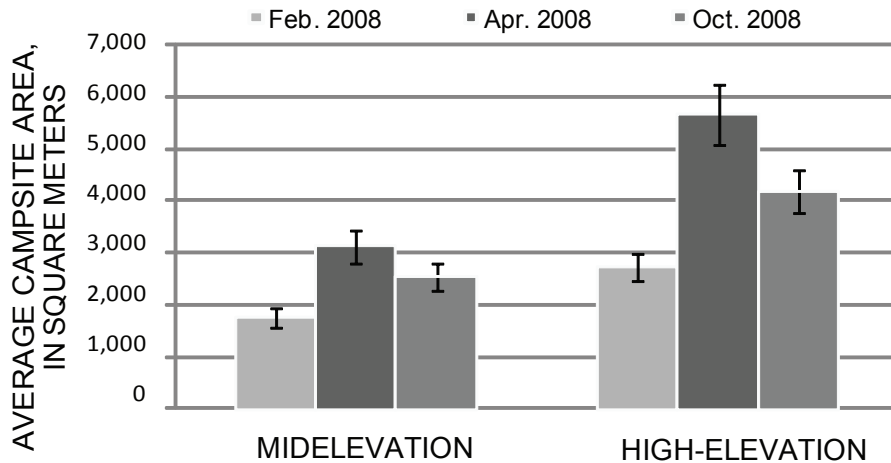
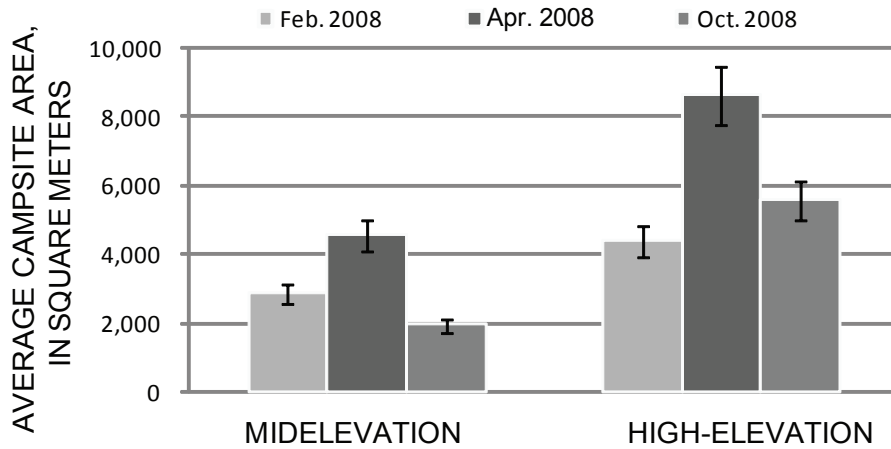
Figure 22. Average campsite area above the reference stage before, after, and about 6 months after the 2008 HFE. Error bars show plus and minus 10 percent of total. *A*, Critical reaches. *B*, Noncritical reaches.

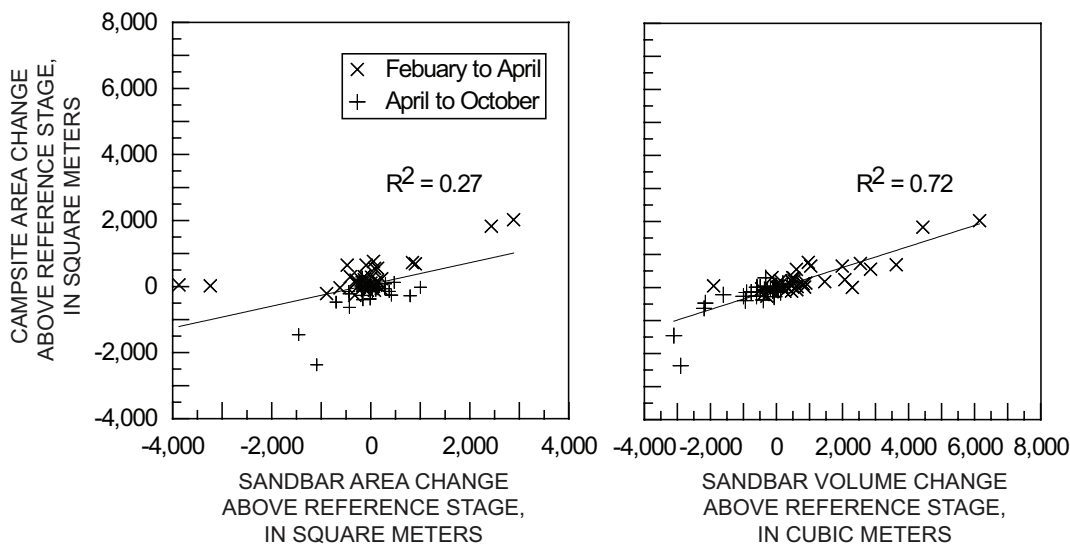
Figure 23. The relation of change in campsite area to change in sandbar area and volume for two time intervals in 2008, pre- to postflood (February-April) and the following 6 months (April-October). A linear regression fit for both time intervals combined is shown.

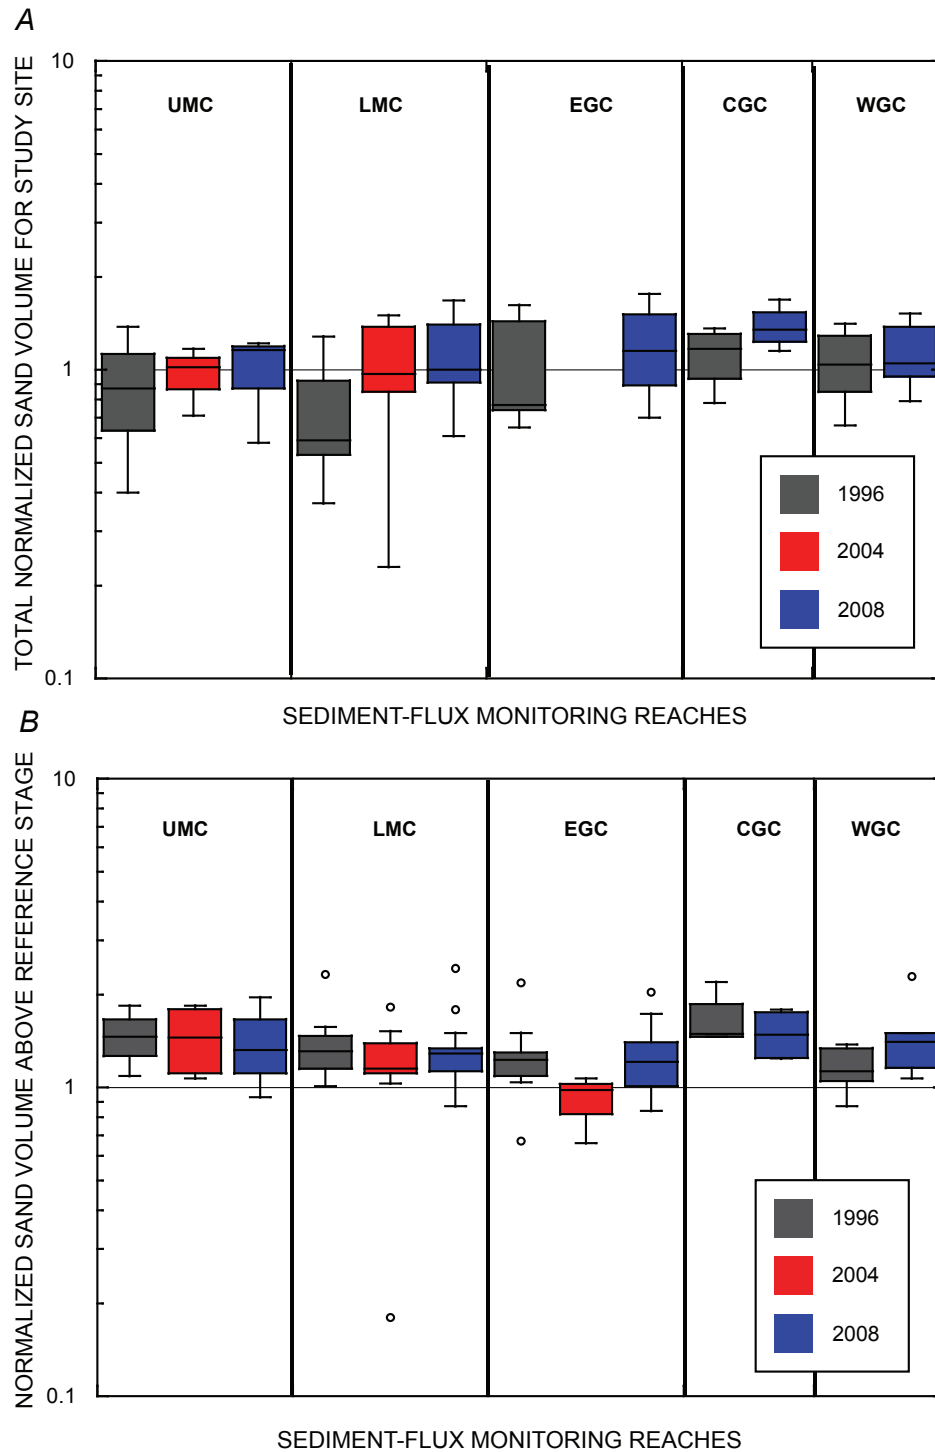
Figure 25. Boxplots showing normalized sand volumes of all sites within each sediment-transport-flux monitoring reach. Sand volumes are normalized by dividing the volume measured following each high flow by the volume measured before the 1996 HFE and shown on a logarithmic scale. Upper Marble Canyon (UMC), lower Marble Canyon (LMC), eastern Grand Canyon (EGC), central Grand Canyon (CGC), and western Grand Canyon (WGC) reaches are shown. *A*, Total-site volume. *B*, Above-reference-stage volume. A boxplot summarizes the distribution of data by showing the interquartile range (25th percentile to 75th percentile) as the height of the box, the median value as the center line within the box, lines drawn to smallest and largest values within one step (equal to 1.5 times the interquartile range) beyond either end of the box, and outliers (values greater than two steps outside the box) as circles.
